Inspection Report

Property Address:
238 sw 132nd terr
Newberry FL 32669

Thurmond Home Inspections, LLC

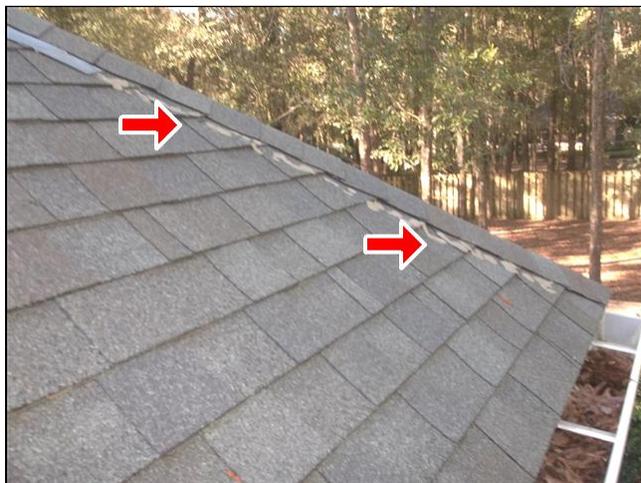
1.1 Item 1(Picture) Missing Flashing

I also suggest a qualified person replace the missing flashing

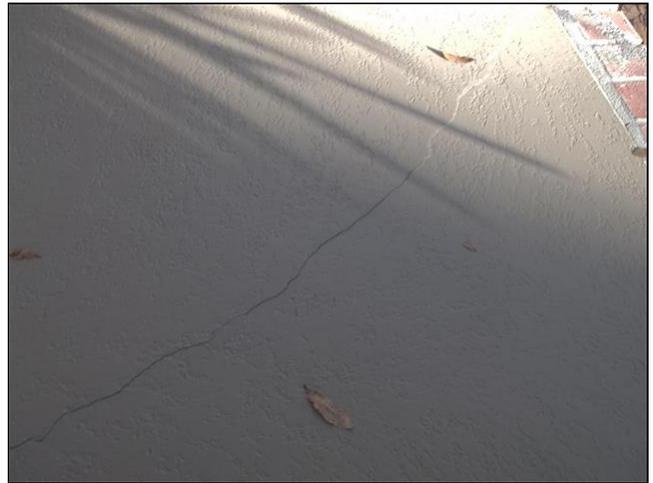
2.4 Item 4(Picture) Evidence Of Step Cracking

I strongly suggest addressing the drainage system by the front corner of the home, like we talked about during the inspection. Nonuniform water drainage is the most common cause of settling and foundation issues.

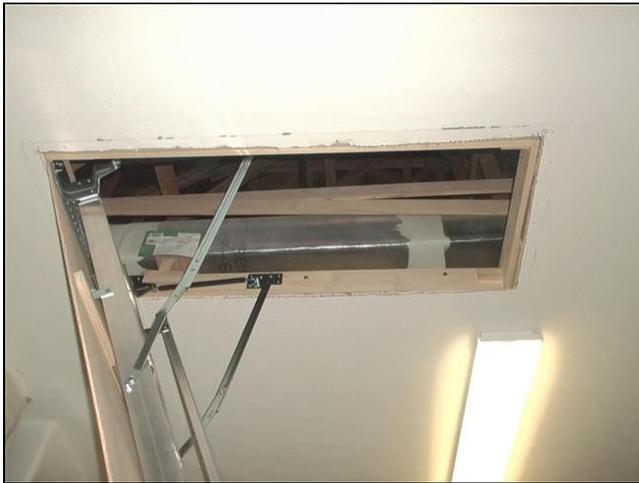
3.0 Item 3(Picture) Attic Access Is Missing Trim

Ceiling around attic access is missing trim.

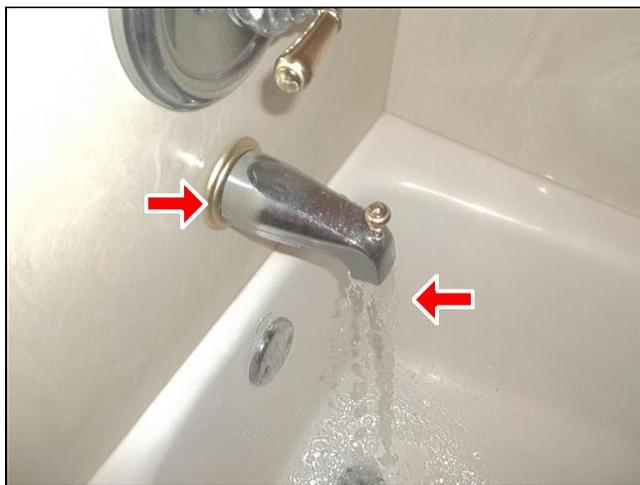
5.1 Item 7(Picture) Guest Bathroom Bathtub Fixture Is In Need Of Repair

The upstairs guest bathroom has a damaged bathtub fixture. I suggest a qualified person repair or replace as needed.

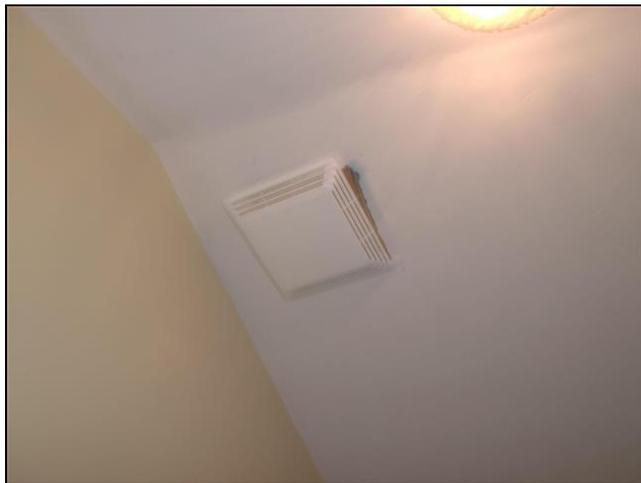
8.2 Item 1(Picture) Upstairs Guest Bathroom Vent Is Damaged.

The upstairs bathroom ventilation fan sounds damaged and the cover isn't secured. I suggest repair or replacing it as needed.

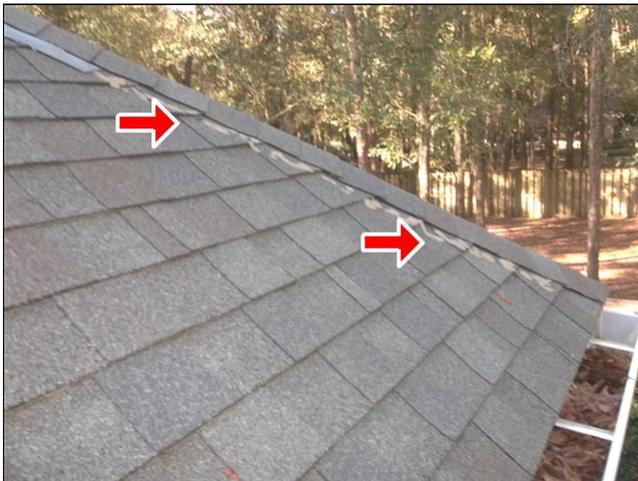
1.1 Item 1(Picture) Missing Flashing

I also suggest a qualified person replace the missing flashing

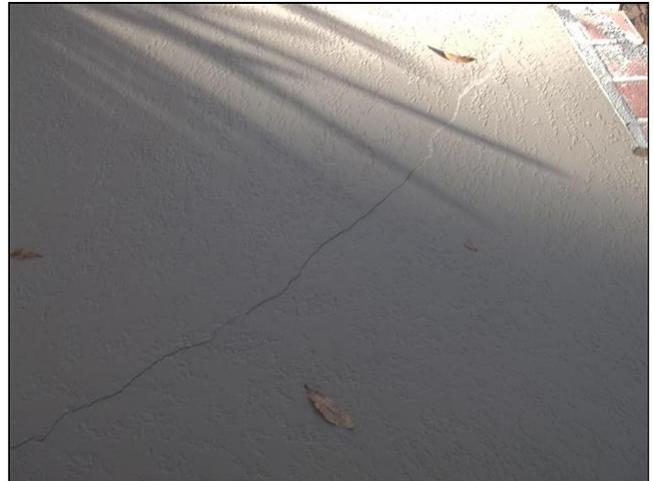
2.4 Item 4(Picture) Evidence Of Step Cracking

I strongly suggest addressing the drainage system by the front corner of the home, like we talked about during the inspection. Nonuniform water drainage is the most common cause of settling and foundation issues.

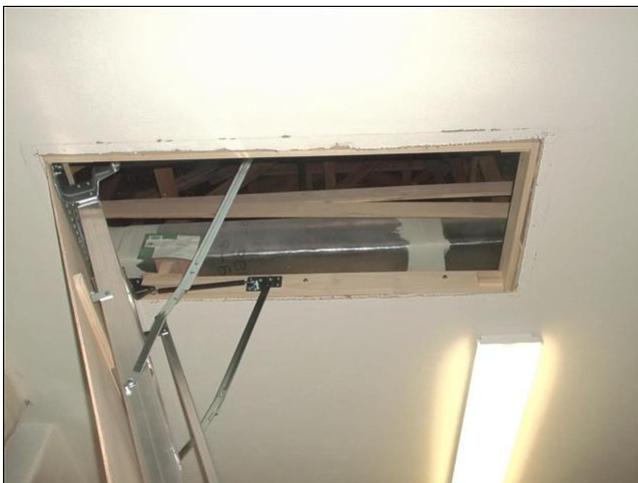
3.0 Item 3(Picture) Attic Access Is Missing Trim

Ceiling around attic access is missing trim.

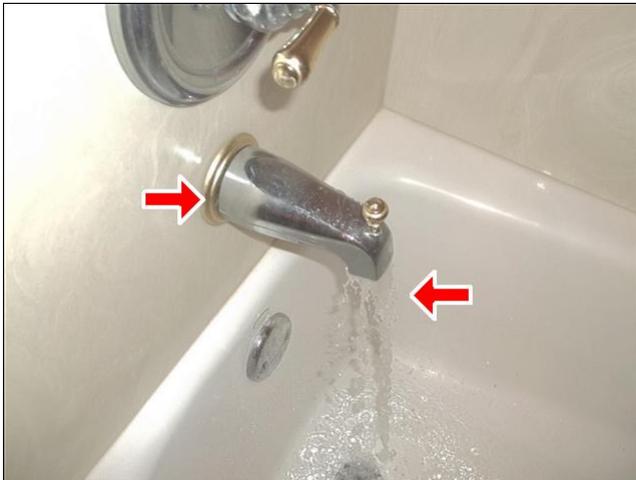
5.1 Item 7(Picture) Guest Bathroom Bathtub Fixture Is In Need Of Repair

The upstairs guest bathroom has a damaged bathtub fixture. I suggest a qualified person repair or replace as needed.

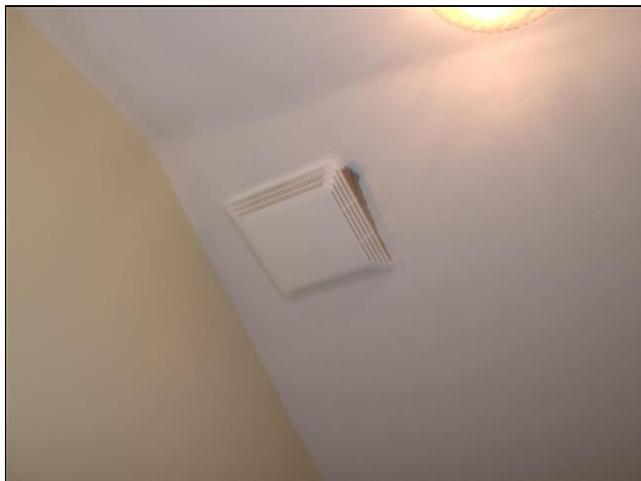
8.2 Item 1(Picture) Upstairs Guest Bathroom Vent Is Damaged.

The upstairs bathroom ventilation fan sounds damaged and the cover isn't secured. I suggest repair or replacing it as needed.
