Inspection Report

Property Address:
9320 NW 238th Street
Alachua FL 32615

Thurmond Home Inspections, LLC

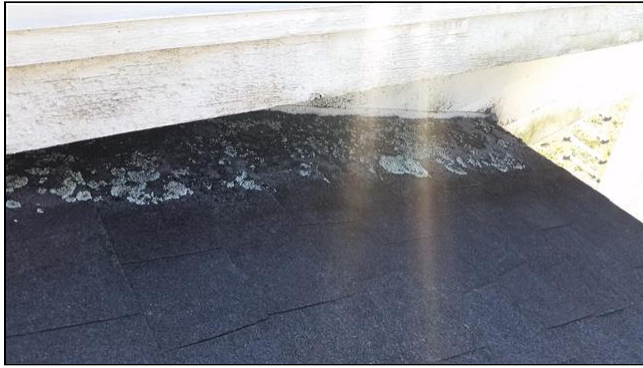
1.0 Item 1(Picture) Organic Growth

There is organic growth on the back of the roof. I suggest treating the shingles to get rid of the growth.

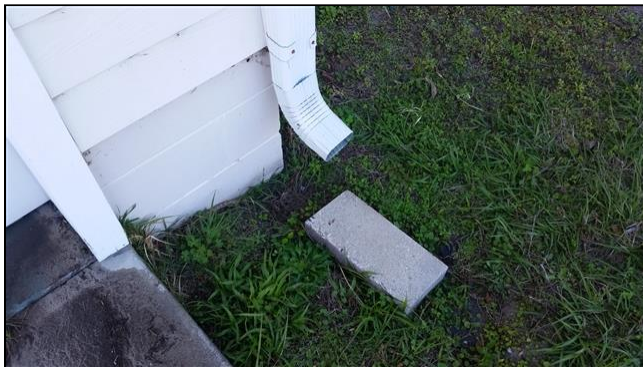
1.3 Item 1(Picture) Gutter Guide?

I suggest adding gutter guides to direct rain flow away from the structure.

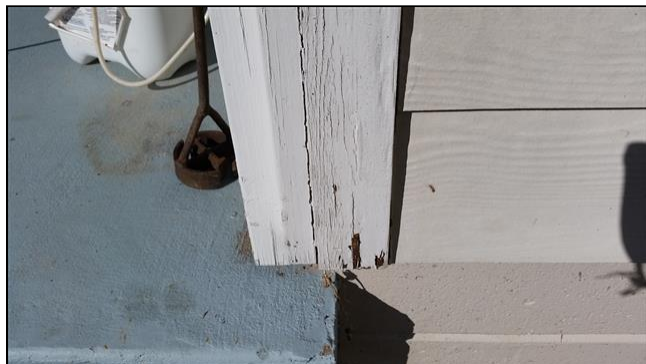
2.0 Item 1(Picture) Wood Rot

There is wood rot scattered around the home. I suggest having the trim work repaired or replaced.

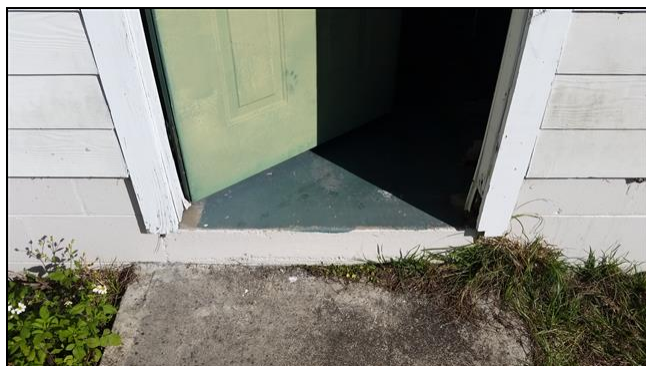
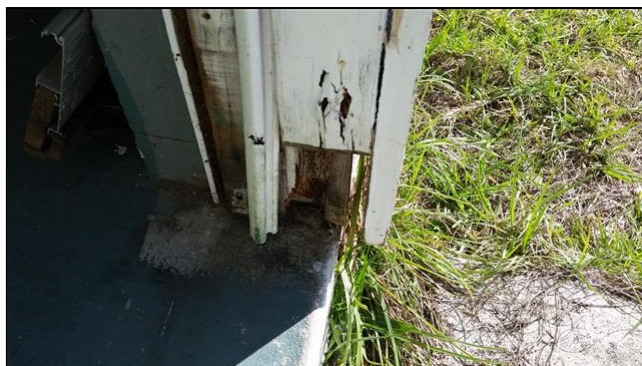
There is wood rot on the trim work of the exterior door to the garage. The frame is also damaged. I suggest repairing the door as needed.

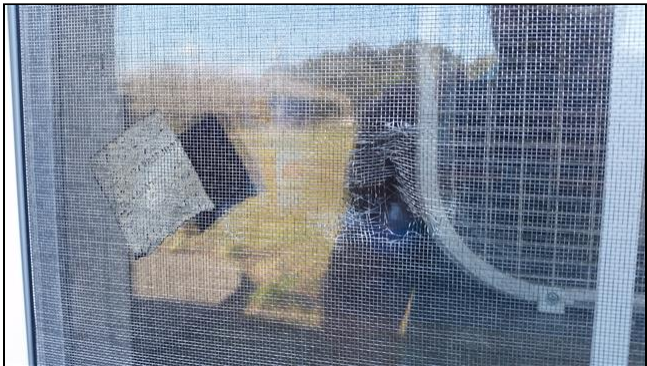
2.2 Item 1(Picture) Damaged Screen

There is wood rot on some of the window trim. There is a damaged screen on the front guest bedroom. I suggest repairing the wood work and replacing the screen.

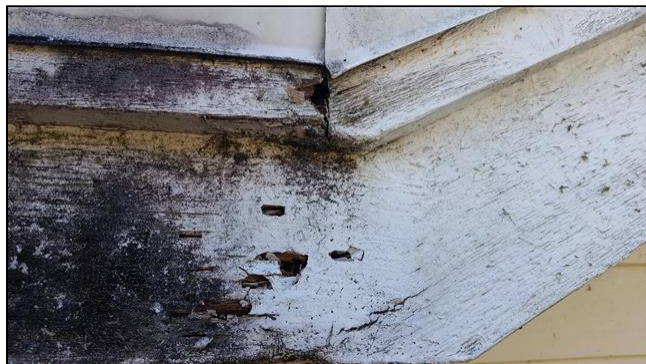
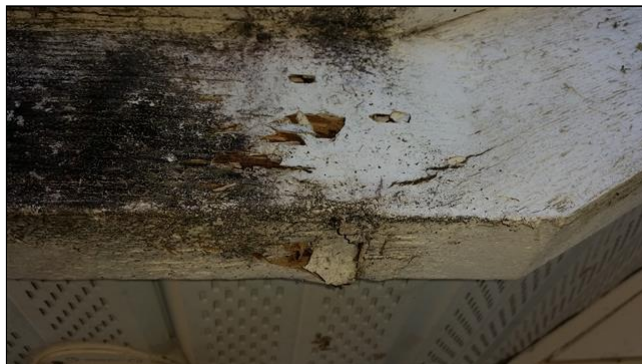
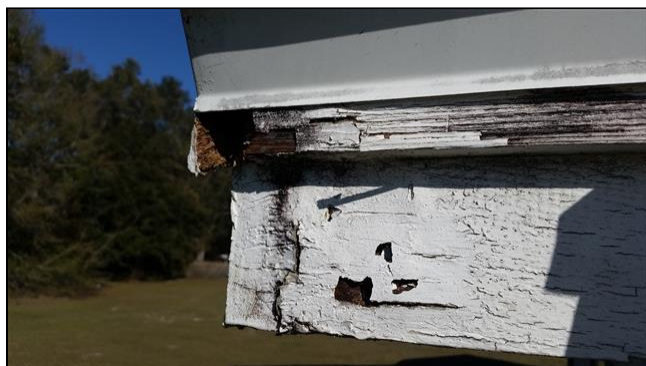
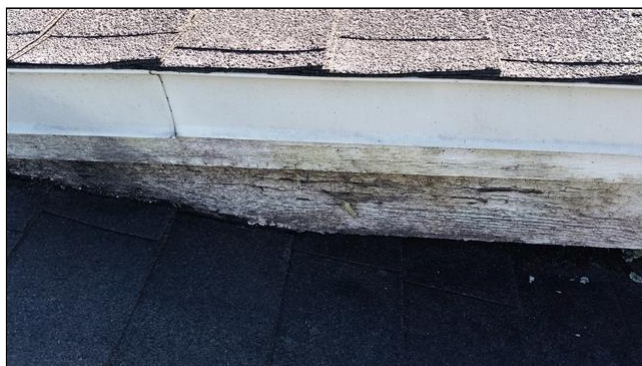
There is wood rot on the fascias. I suggest repairing them.

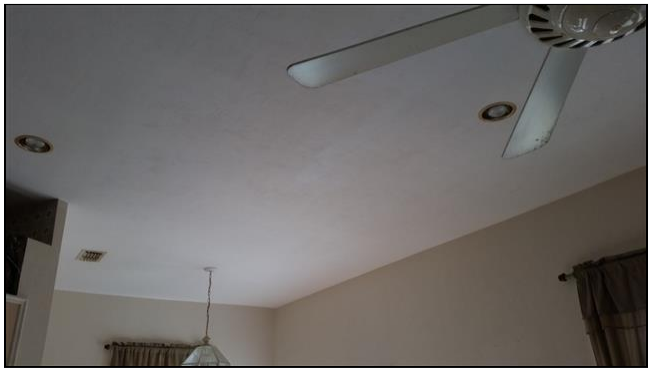
4.0 Item 1(Picture) Ceilings

There are moisture stains in the ceiling.

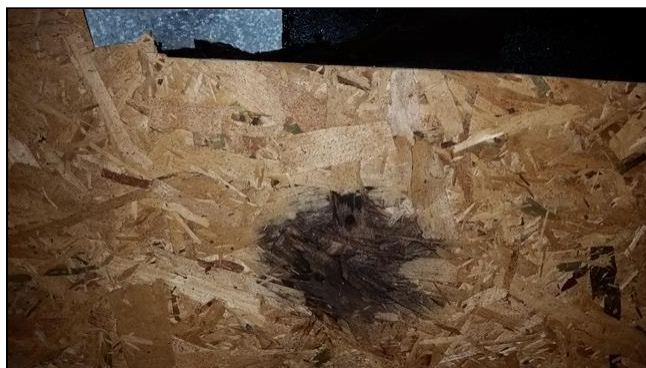
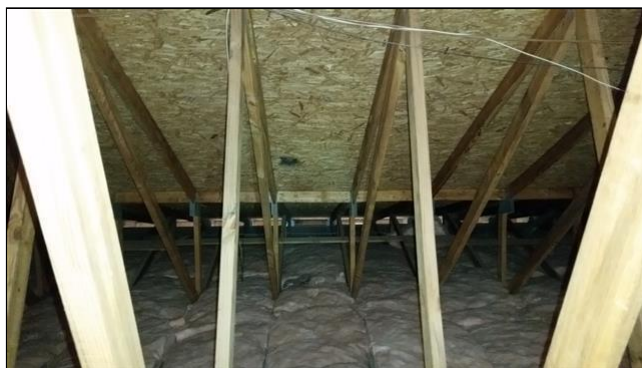
The roof structure has evidence of two moisture intrusions. I suggest having a licensed roofing contractor further investigate it.

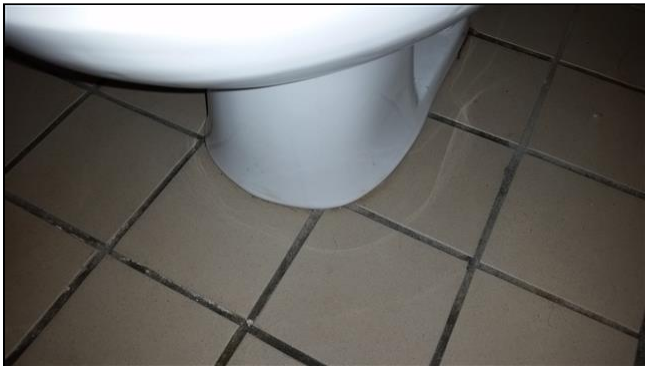
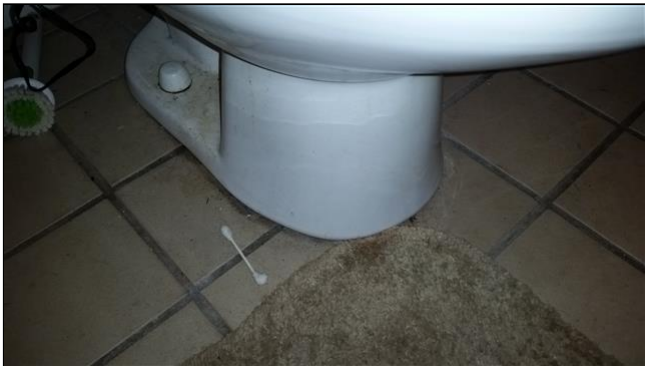
The toilets need to be secured to the floor.

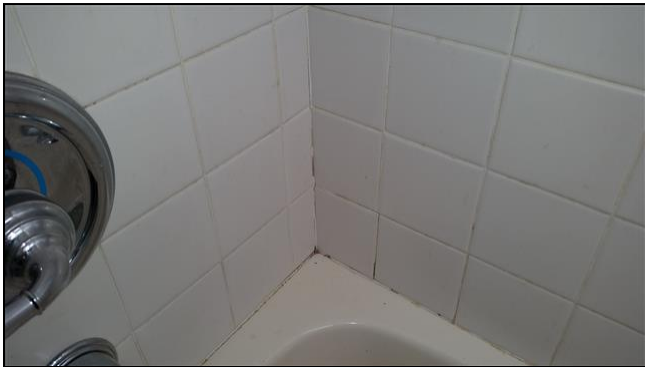
6.1 Item 1(Picture) Caulk?

I suggest caulking the tile work in the bathrooms to help prevent moisture intrusions. I also suggest clearing out the clogged drain in the master bathroom sink.

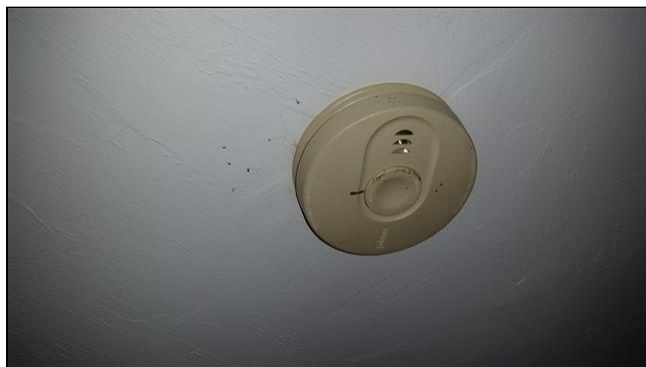
7.7 Item 1(Picture) Smoke Detector

I suggest replacing the batteries in the smoke detectors upon moving into the home.

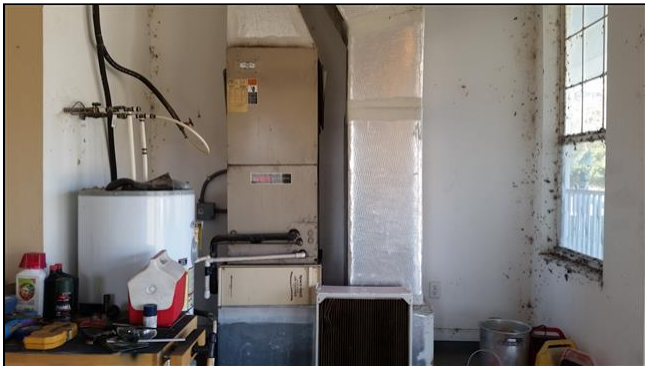
8.0 Item 1(Picture) Heating Equipment

The HVAC systems are not functional at time of inspection. I suggest having them serviced by a licensed HVAC contractor.

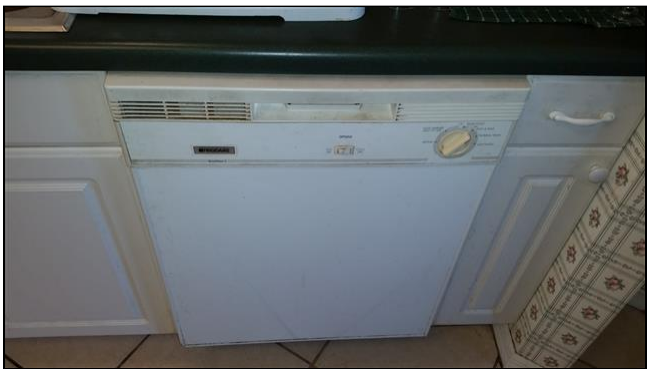
10.0 Item 1(Picture) Dishwasher

The dishwasher is not functional at time of inspection.
